Manhole Inspection Summary

Manhole # S21EE_016MH

Location Address: **1716 LAURENS ST**

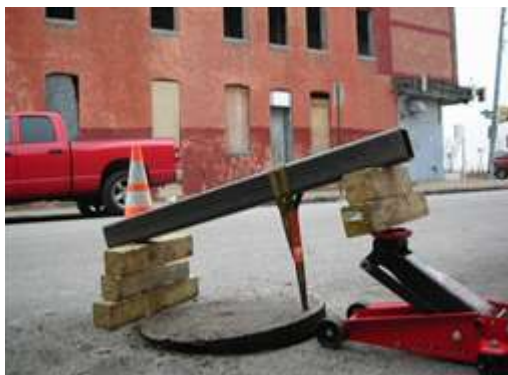
Location View

OPENED USING JACK AND BOLT METHOD

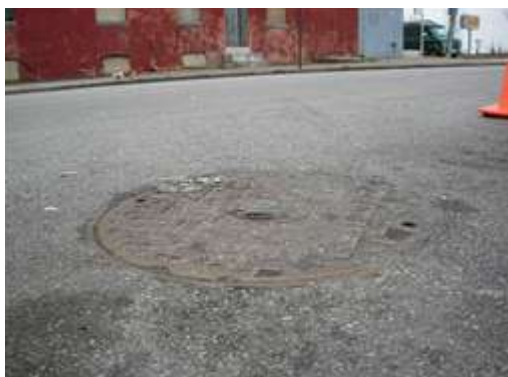
OBSERVED STUCK 24" COVER ON LAURENS ST

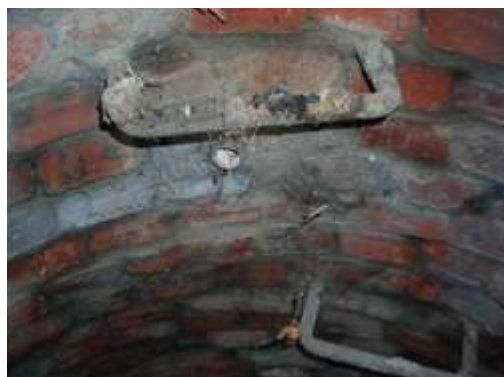
PIPE INTRUSION

CLEANOUT

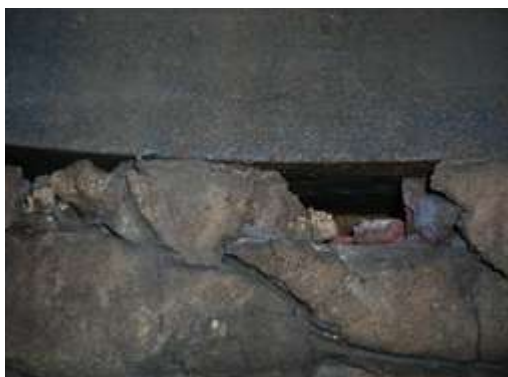
Defect 5

Condition: ☐ Sound ☒ **Cracked** ☐ Root Intrusion ☐ Loose Brick ☒ **Deteriorated**

CHIMNEY ADJUSTMENT IS CRACKED AND DEGRADED

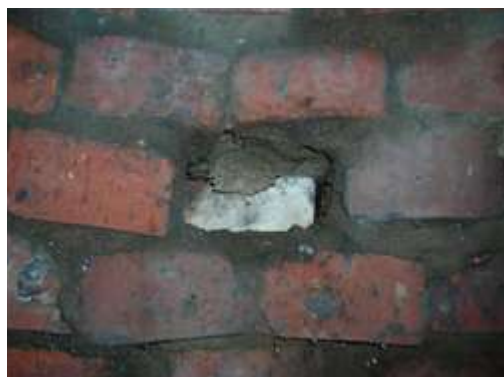
Defect 4

Condition: ☐ Sound ☐ Cracked ☐ Root Intrusion ☒ **Loose Brick** ☒ **Deteriorated**

MISSING BRICK IN CORBEL WALL

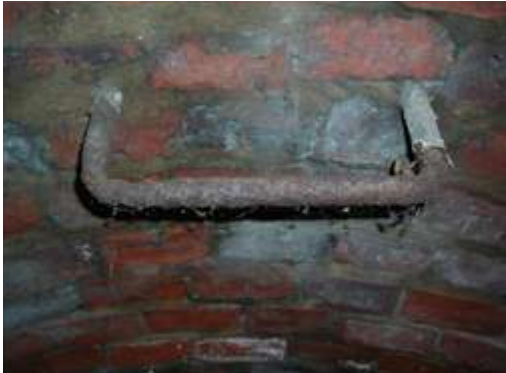
Defect 3

CORRODED STEP

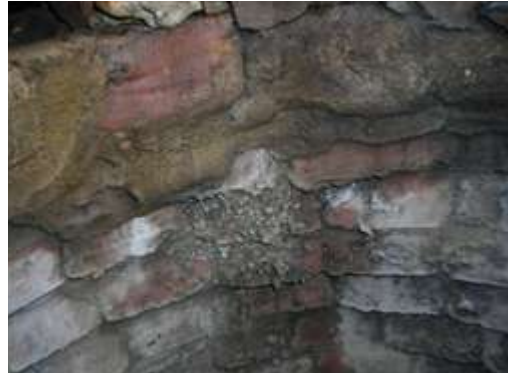
Defect 2

EVIDENCE OF INFILTRATION ON
CORBEL WALL

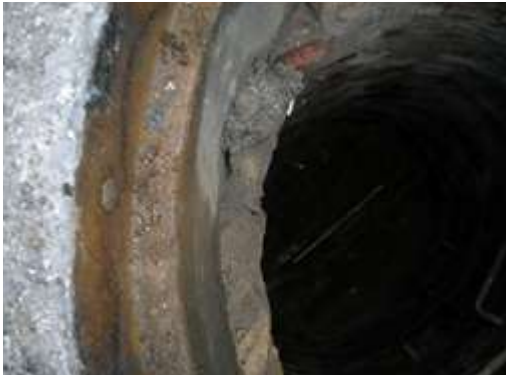
Defect 1

Offset: **2** (in.)

FRAME OFFSET 2"

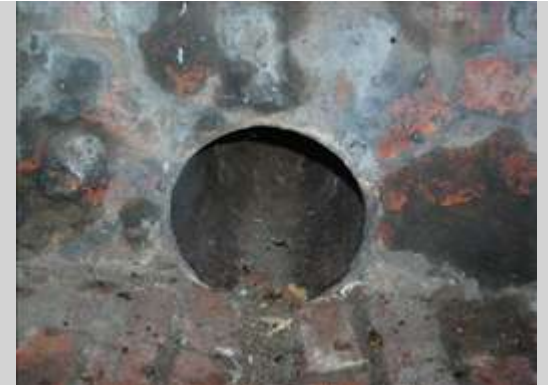
12 O'Clock Outflow

10 in. Circular Gravity Sewer
Pipe Out @ 12 O'Clock

Pipe Height: **9.6** (in.) Rod and Bar (Angled)

Pipe Material: **Clay** ☐ Pipe Lined

Invert Depth: **9.67** (ft.) Flow Characteristics: **None**

Infiltration: **None** Pipe Seal Cond: **Sound**
